Dekro Paints

KENILWORTH VILLAGE

EXTERNAL
REDECORATION
CASE STUDY

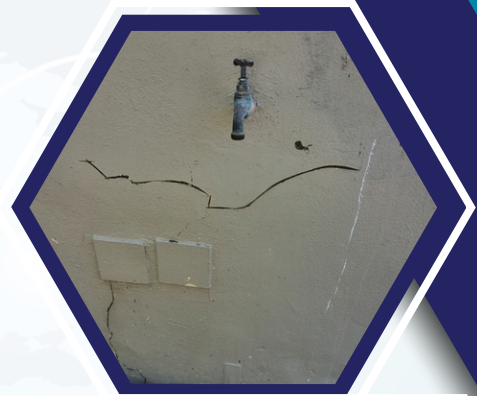
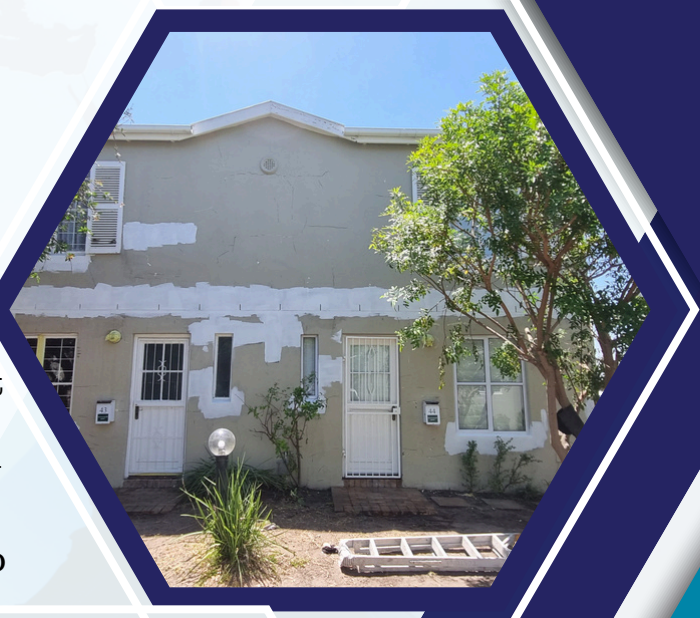
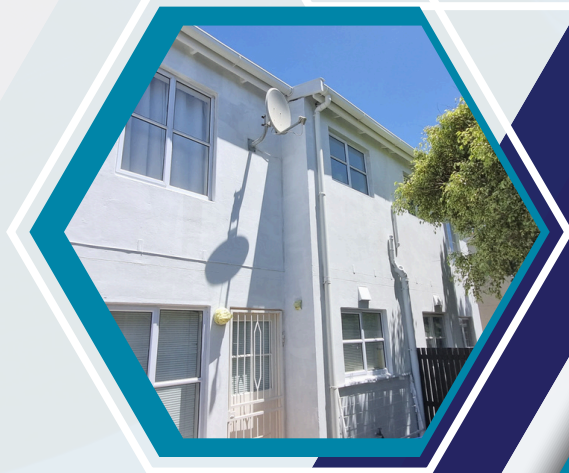
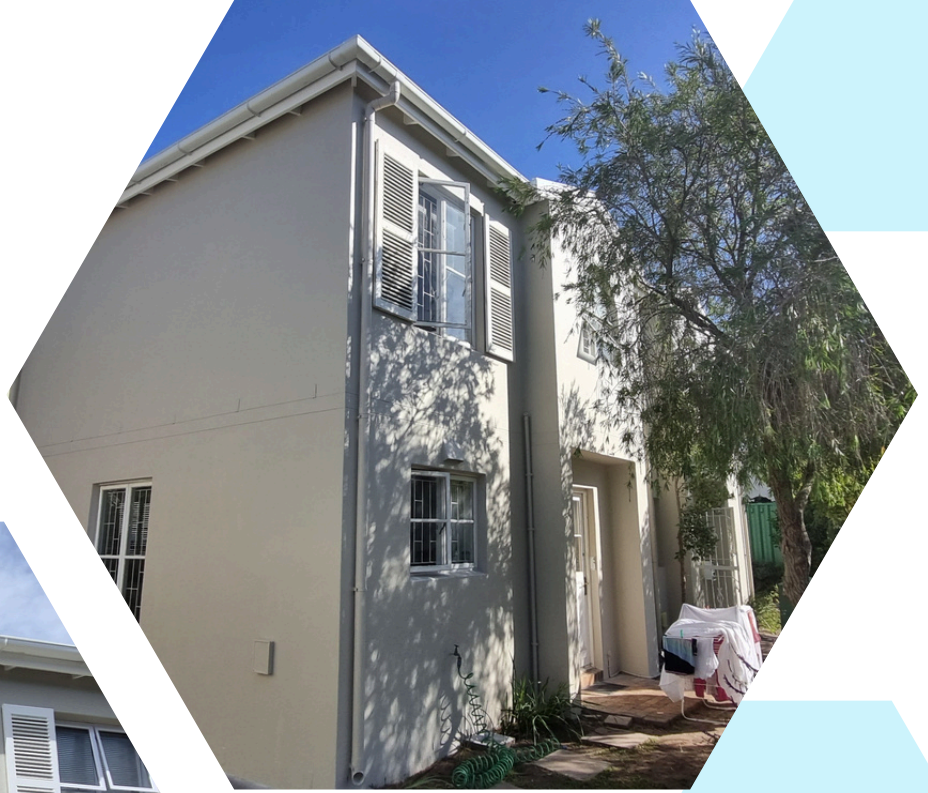
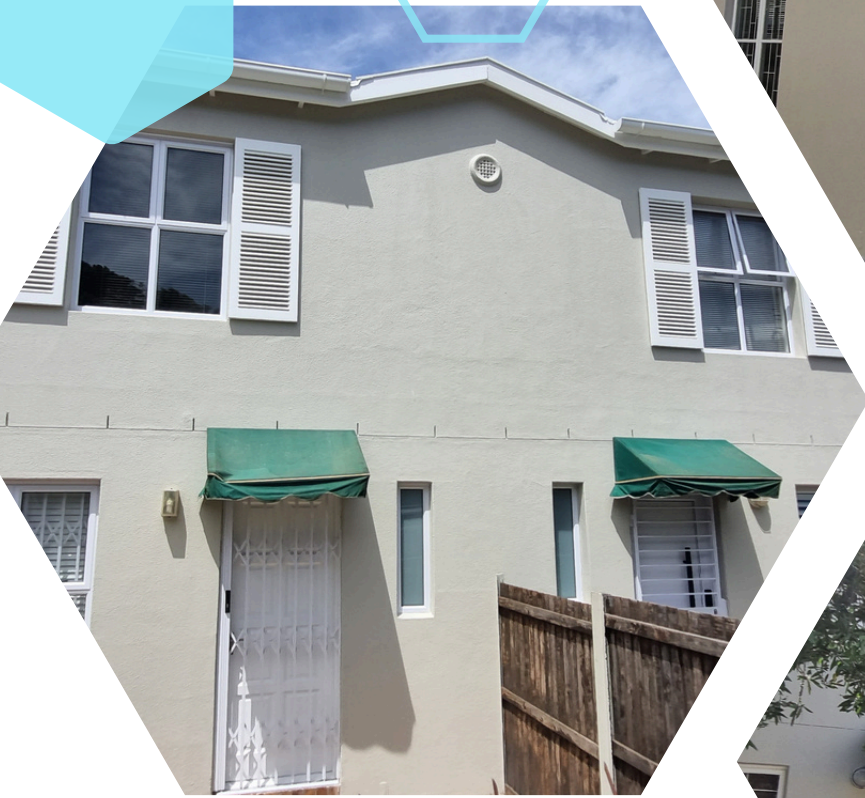
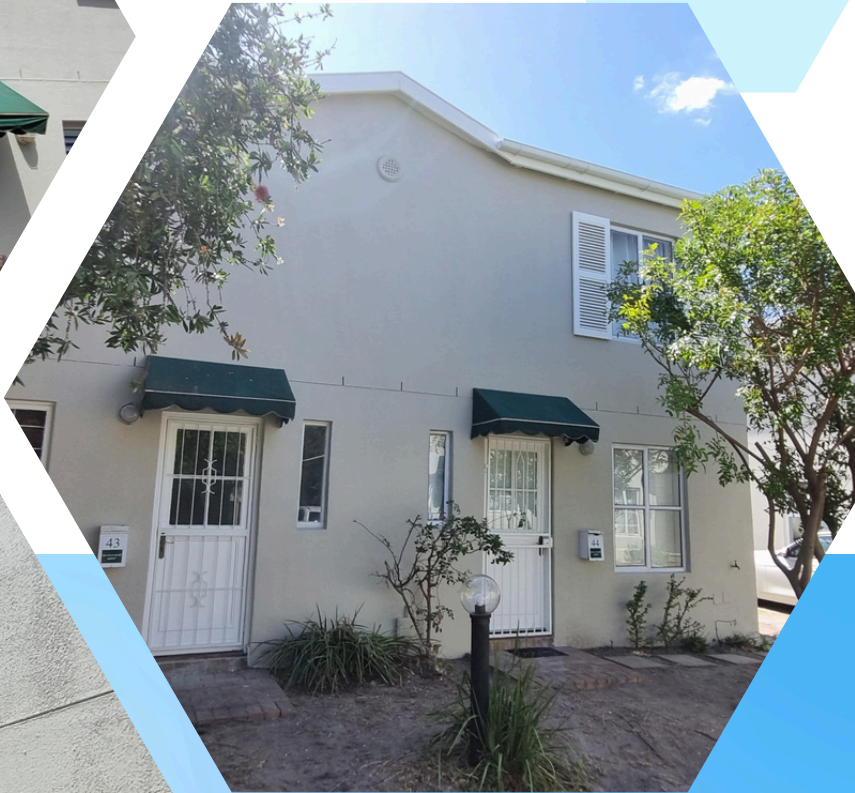
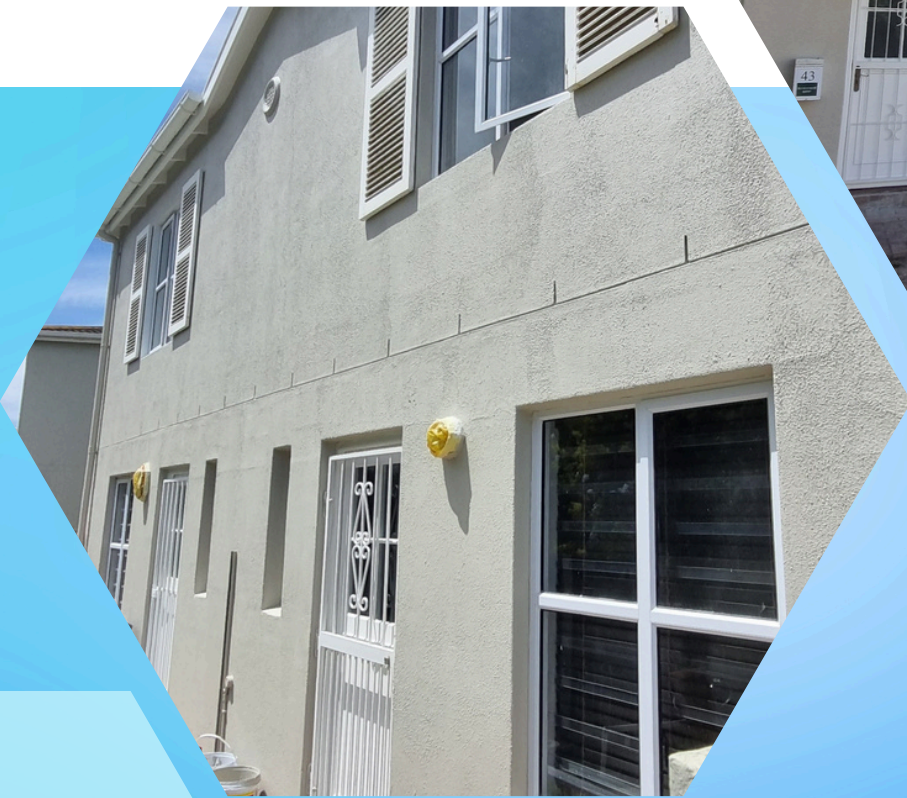
Kenilworth Village comprises of duplex double storey units. The existing coatings had long surpassed the life expectancy with obvious degradation and coating failure evident in areas. This failure is often linked to obvious water or moisture ingress which leads to issues such as efflorescence, blistering and delamination of coatings.

Due to the existing DPC having deteriorated over time, new DPC had to be installed to assist with the existing waterproofing issues.

Taking these factors and the amount of movement the units endure, a specification was provided for the bridging of the severe weather mapping (fine hairline cracks) on weather facing walls and to provide a coating system that provides flexibility, durability and waterproofing properties as well.

A full primer coat was applied to provide good adhesion for the new coatings, as well as to prevent alkalinity burn and chalkiness.

Dekro Rippletex was applied on the weather-facing facades for that extra protection against fine hairline cracks, followed by two final coats of Dekro Super Fibretex.
