MV : MT Determination

Tema Ship Yard

PAINTING REPORT for DRY DOCKING

Vessel Name:	MT Determination
Report Date:	7-Mar-2026
Reference No.:	1
CMP Sales Office:	J-KURE(呉)

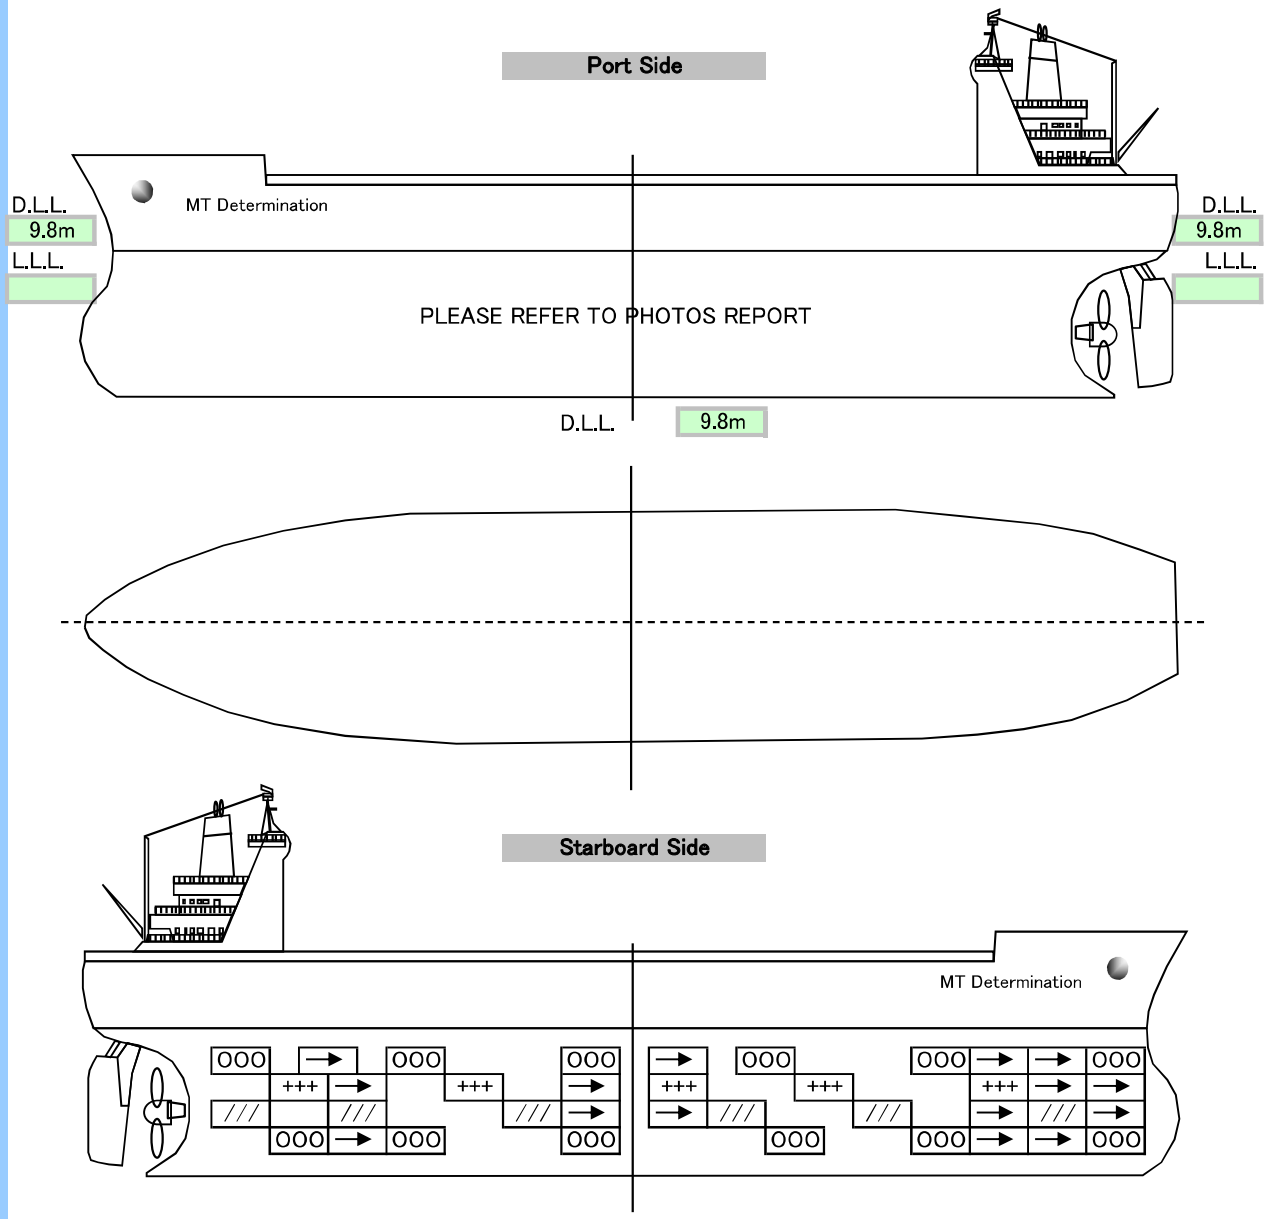
Blisters

Each condition			Total evaluation
		Forward	Middle	After	
Flat Bottom	P	N	N	N	F
	S	N	N	N	F
Bilge Keel to L.L.L.	P	N	N	N	F
	S	N	N	N	F
Boottop	P	N/A	N/A	N/A	N/A
	S	N/A	N/A	N/A	N/A
Topside	P	N	N	N	F
	S	N	N	N	F

Corrosion caused through poor preparation by not feathering the edges.

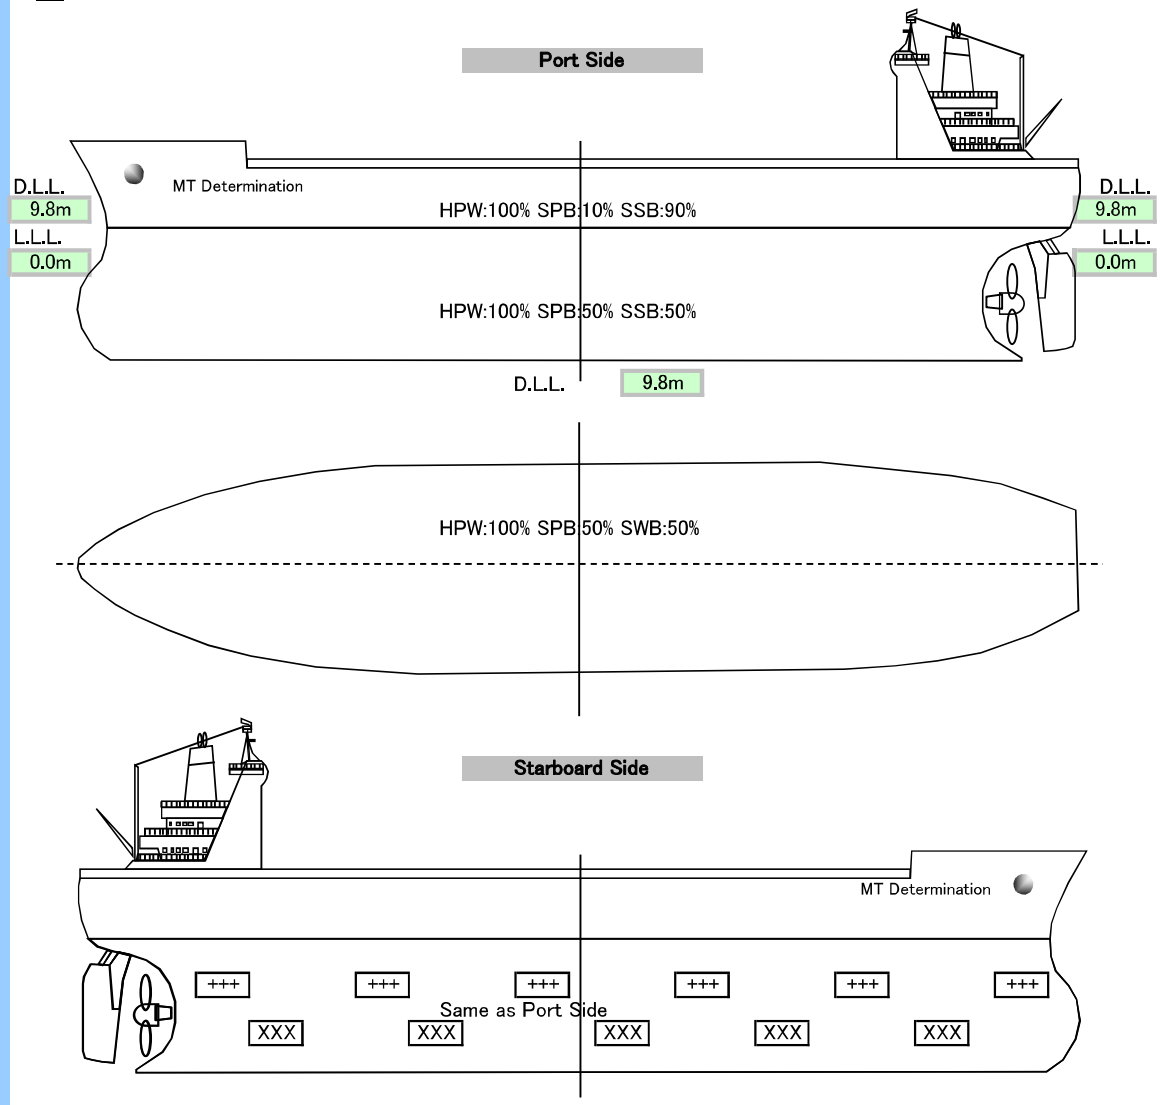
Fender was damaged on the middle of Vertical bottom.

Scratches was found on the port and starboard verticle sides due to the vessel rubbing against fender on quay side. Mechanical damage was found by the bow port and starboard due to ancoring.

Slight and moderate green seaweed and slime were observed on Vertical Bottom below draft.

Slight barnacles has 3mm diameter were scattered on the starn of the bottom.

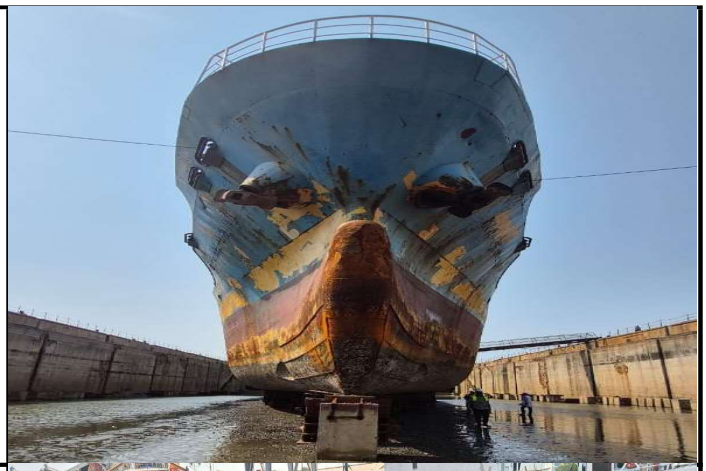
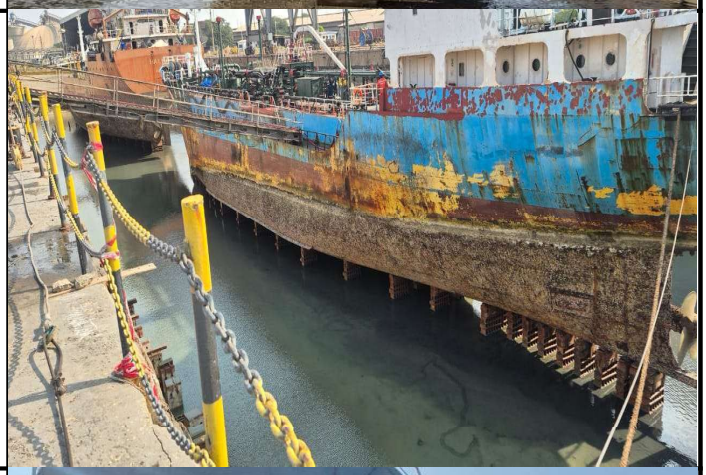
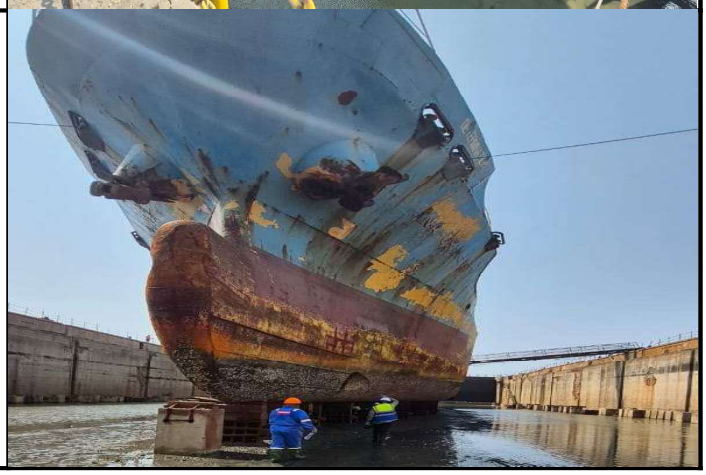
Considering the 5 year specification it was expected to look the way it did with barnacles
scattered all over the underwater area of the vessel.
Corrosion caused through poor preparation by not feathering the edges.

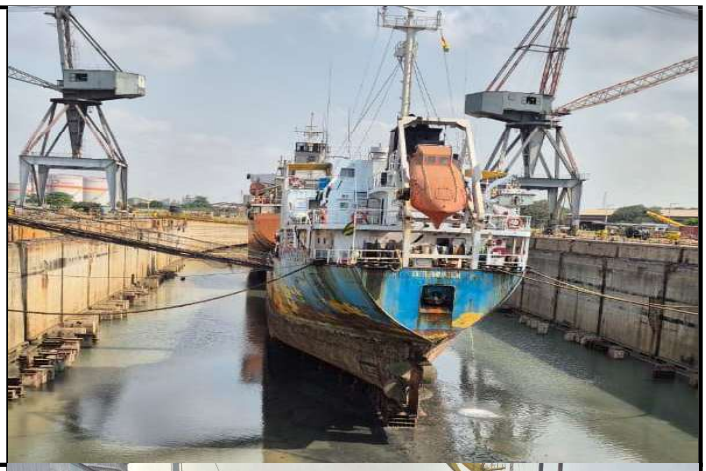
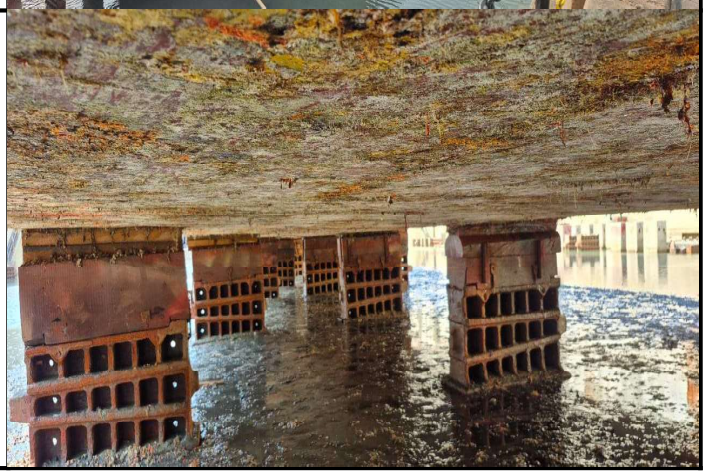
Photographic log showing – Vessel condition on arrival

05/03/2026 MT Determination condition on arrival Commence with washing and scrapping off barnacles.	
Ditto	
Ditto

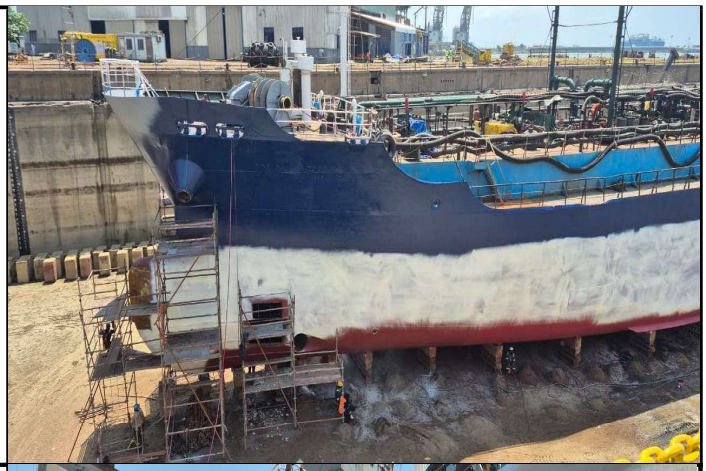
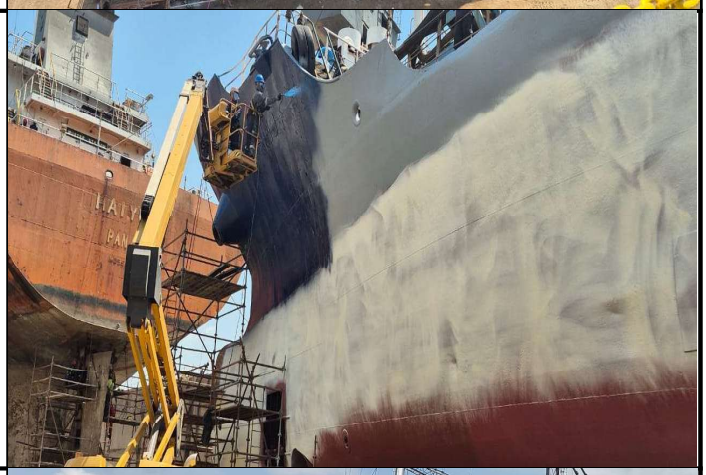
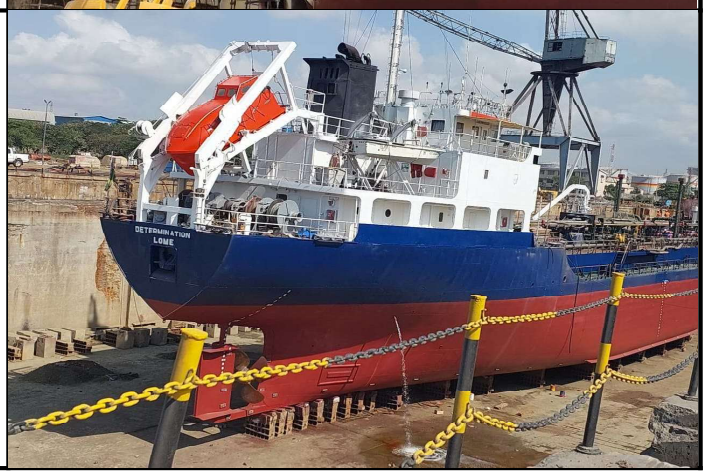
Photographic log showing –

Ditto	
Ditto	
Ditto

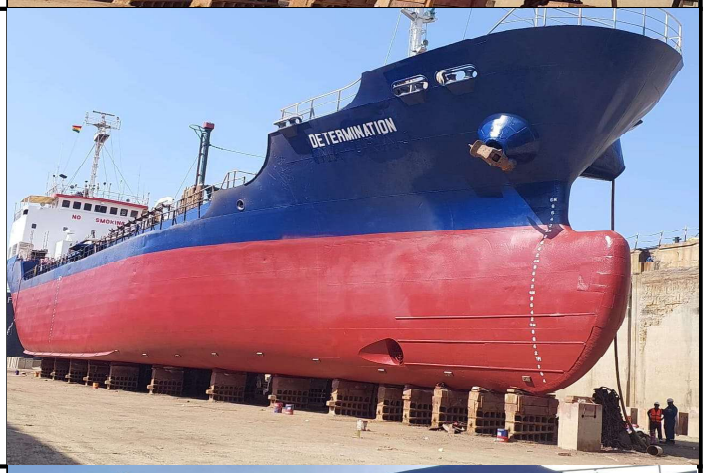
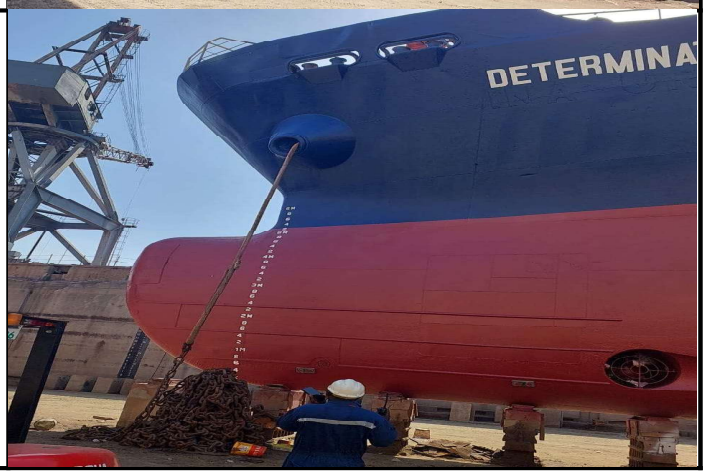
Photographic log showing – Complete Vessel

Ditto	
Ditto	
Ditto

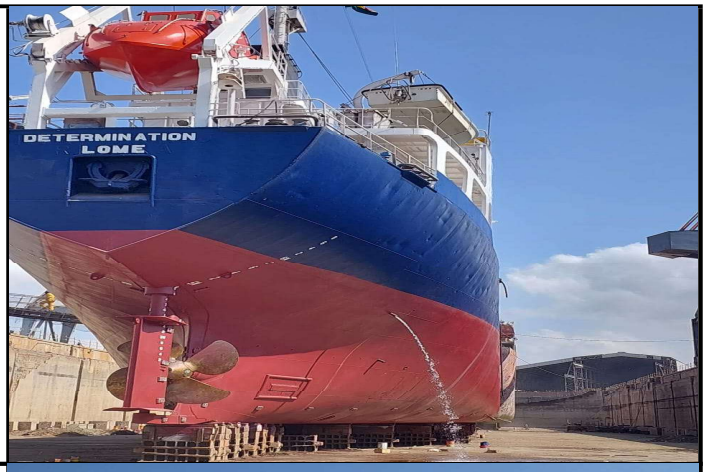
Photographic log showing – Complete Vessel

Ditto	
Ditto	
Ditto
